Case Hístory

Custom-designed mixer shaft seal eliminates waste and hazards

A soy ingredient manufacturer experienced significant product loss and an explosion hazard before replacing ineffective gland seals with custom-designed split shaft seals.

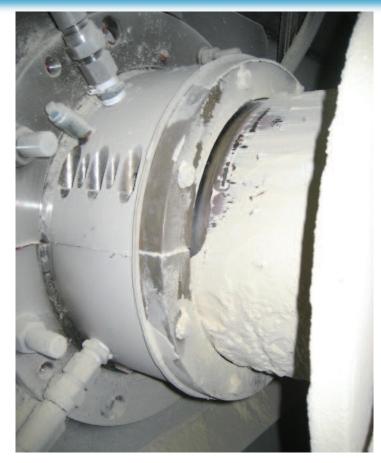
"The blender's conventional packing gland seals deposited a pile of wasted product over one-half meter deep every day," says Steven Vandevyver, the manufacturer's reliability engineer. "One cause of the leak was a 6-millimeter eccentric runout after the blender shaft had been broken and rewelded several times."

The original packing-gland seal at this soy product manufacturer's plant lost product of up to % meter per day.

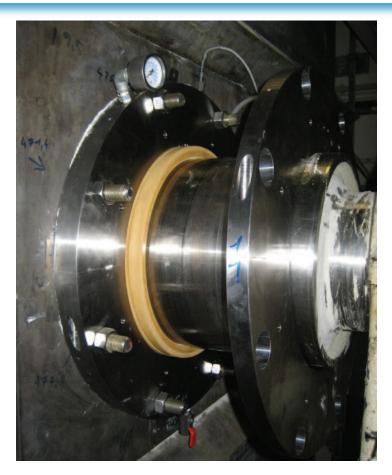
The new custom-engineered seals have their drive elastomer and rotors installed.

After receiving the specifications, the supplier designed a variation of its seal, which would allow up to 6 millimeters eccentric rotation of the blender's shaft. The supplier also ensured that the custom seal would meet ATEX requirements and fit the manufacturer's mounting-bolt pattern for its existing packing-gland-seal stuffing box.

The model AH shaft seal design is fully split, making it unnecessary to remove the bearing or drive assembly before installing the seal and drastically reducing replacement time. The seal is comprised of 2-inch stainless steel plate stators - one inboard and one outboard. The seal's inboard stator mounts against the machine and the outboard stator mounts to the inboard stator. Between the stators are two rotors and a drive elastomer, all of which turn with the blender's shaft. Air pressure between the two stators pushes pressurized air back into the ribbon blender so anything wanting to get out will meet a pressurized air force against it. This is deadheading the air inside the chamber, creating virtually no leakage at all and with a pressure point of 0.25 bar, says the supplier.

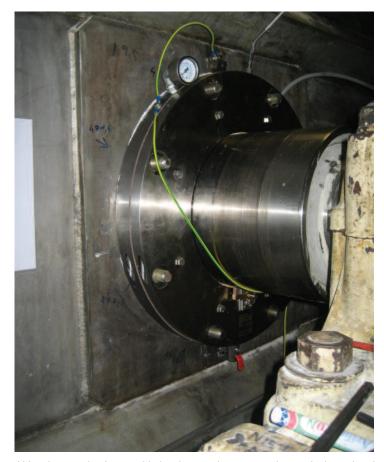
The new AH seal is completely assembled with grounding wires and static discharge brush installed to prevent dust explosion risks.

In January 2012, the manufacturer installed the new non-drive-end seal, and in February it installed the driveend seal. Installation was simplified because the seals were custom-designed to the manufacturer's ribbon blender specifications. The new seals created a tighter seal, eliminating product loss and eliminating the explosion hazard.

Once the seals' sacrificial face material begins to wear away, the seals can be adjusted by removing one of a stack of adjusting gaskets and reassembling the seals, a process that only takes a few minutes. Periodic adjustment of the
